#### NORTH HAMPTON SALT MARSH STUDY

Part I: Assessment of Little River Marsh and Bass Beach Marsh

Part II: The problem, recommended solutions, and projected outcomes

October 31, 1984

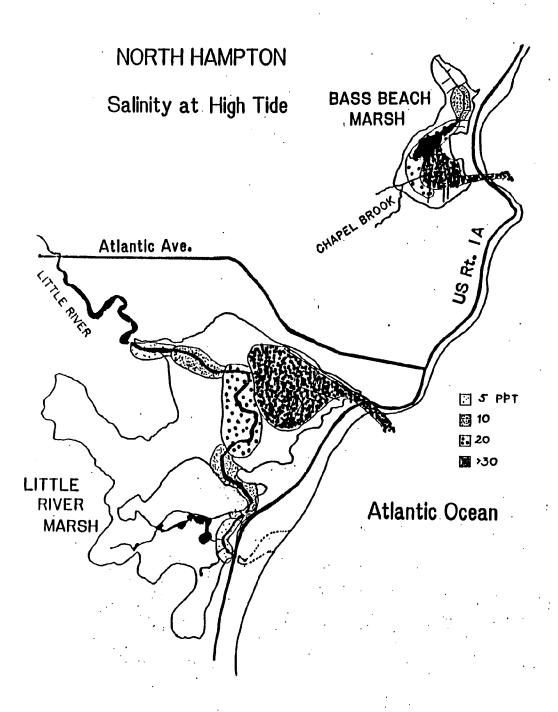
Salinity distribution at high tide (parts per thousand) in the two North Hampton marshes. Ocean water extends into the marsh, pushing the fresh upland water back, and mixing with it in the upper reaches. The dam on the Little River and the blocked channel under Rt. 1A are the upper extents of tidal effects in the Little River Marsh. At the Bass Beach Marsh, ocean water extends into the salt pond, elevating the salinity.

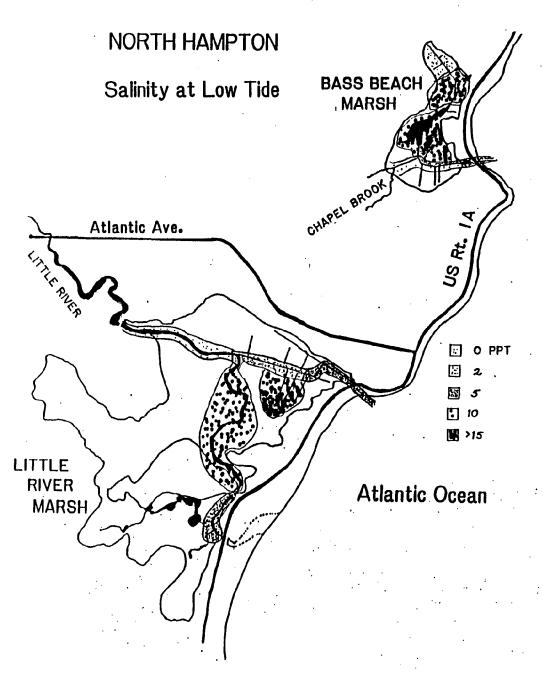
Salinity distribution at low tide (parts per thousand) in the two North Hampton marshes. At low tide, ocean water drains from the marsh and fresh creek water reinvades the lower reaches. Note that the scales of the low tide and high tide figures are different. At low tide, significant portions of the creeks and pannes are not saline. At both marshes, salt water is left behind on the marsh surface as the tide drains, leaving saline pockets, while fresh water from the upland creeks mixes with the receding tidal water in the main channels, diluting the outflow.

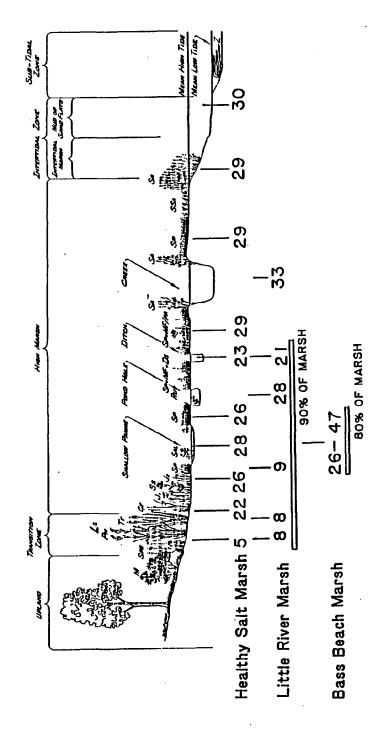
SALINITY OF SEDIMENTS, ppt

Salinity values at the Little Typical salt content of sediment water for a healthy sediment water salinity values in the predominant pannes are as high or higher SP - Spartina patens, SA - Spartina alterniflora, M - Myrica Cr - Sedges (mostly 1 - Juncus spp., SPE - Spartina pectinata, Ss - Solidago sempervirens, Z - Zostera marina, Juncus gerardii, MF - Mixed forbs, SSa - Stunted Sa, Ru - Ruppia maritima, Cr - Sedges (mo River Marsh are lower throughout the Transition Zone and High Marsh, allowing invasion of lossestrife, SAL - Salicornia spp., DS salt marsh with salinity values indicated for specific points across the marsh. Typha spp., J<sub>2</sub> - Juncus gerardii, MF - Mixed forbs, SSa - Stun Scirpus spp.), Ph - Phragmites communis, Ls - Lythrum salicaria, Generalized cross-section of a New England salt marsh. than the healthy marsh. Plant identification: At Bass Beach Marsh, pensylvanica, J and cattail.

Decreased salt content in the sediments of Little River Marsh has greatly reduced the area of high marsh and allows an invasion of Transition Zone (freshwater/terrestrial) plants.

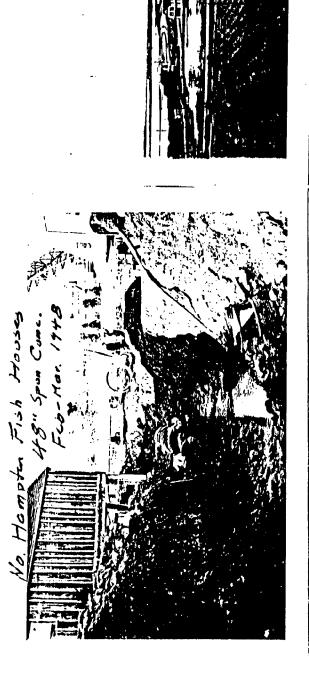
Photos of Little River Marsh and the 48" culvert installed under the fish houses in 1948. Photo at upper right shows the marsh under flood conditions. Photos from the New Hampshire Department of Public Works and Highways.

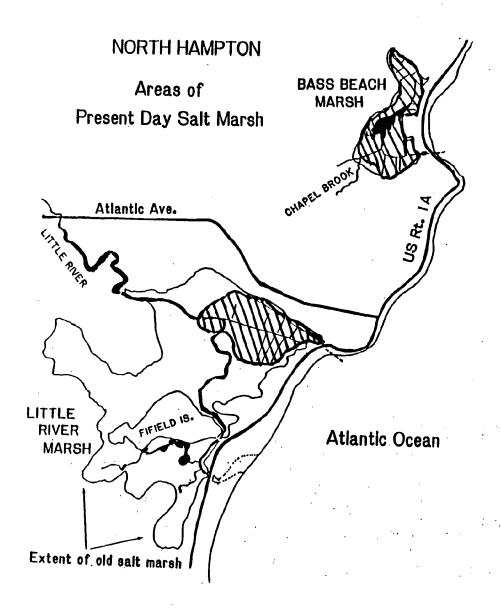
Hatched areas represent the extent of present day salt marsh at Little River Marsh and Bass Beach Marsh in North Hampton, New Hampshire. Actual salt marsh at Little River Marsh is reduced 70% from its former extent. At Bass Beach the salt marsh remains the same size as previously, although 80% of the marsh is dead panne.

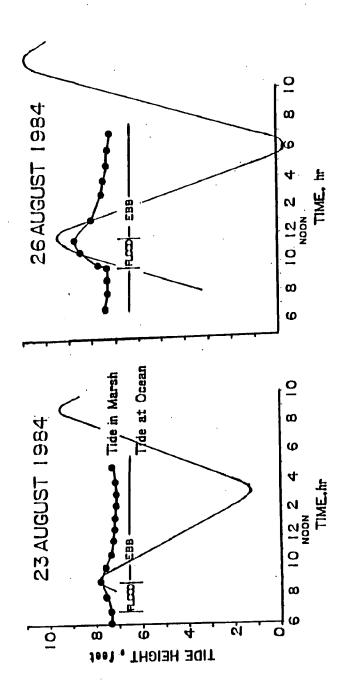
Ocean tide at the ocean (above mean low water) and in the marsh. Tide heights are always height strongly affects the amount of ocean water entering the marsh. Additionally, ebb from the marsh lasts longer than flood because of the relation Tide sequences for two days of varying tidal amplitude, showing tide height much reduced inside the marsh because of the restricted inflow. of the culvert to ocean water level.

My recommendation for increasing water flow in the Little River Marsh is to install a 48" culvert under Route IA, running from the Little River as it passes the north side of Fifield Island, under Route IA and the beach beyond it, out into the ocean, and terminating on the rock ledge found off the beach at that point.

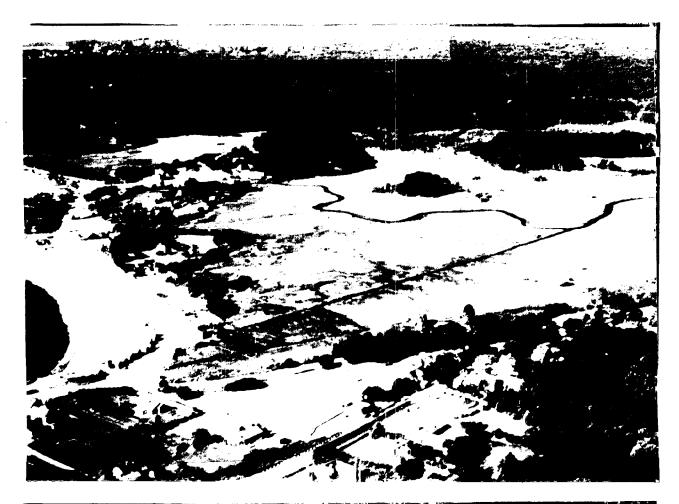
Since much of what was formerly true marsh in the Little River Marsh is now no longer subject to tidal flushing, terrestrial and freshwater marsh plants have begun to invade. The most obvious and aggressive of these is purple loosestrife (Lythrum salicaria) which now covers approximately 60% of former marsh area. Loosestrife is not productive of the detrital material so essential to the food web of the marsh. It doesn't attract birds or animals since it constitutes a barrier rather than a protective habitat for wildlife. The invasion of purple loosestrife is a sure indicator of degradation and loss of salt marsh area.

Little River Marsh showing the invading non-saltmarsh plants.

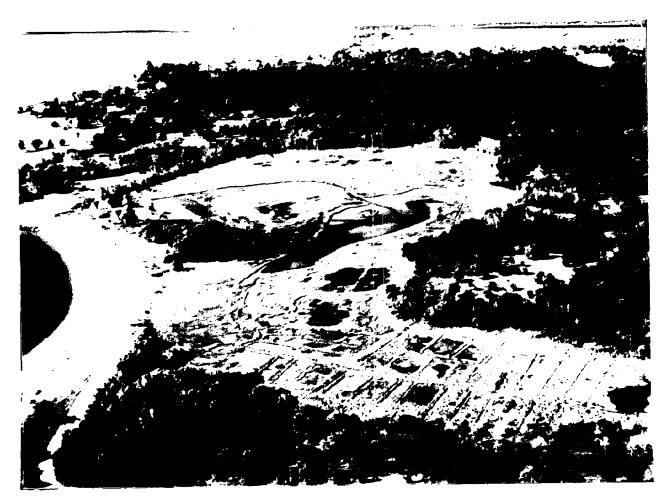
It is hard to say in retrospect exactly what the cause of the dead pannes might have been. However, it seems certain that it is related to the mosquito ditches which rib the marsh surface, creating high margins along the ditches where the earth was thrown when the ditches were dug. These levees may have trapped water between the ditches and made it hard for it to drain. There is some indication in the literature that standing water on the marsh peat causes the peat itself to rot, compact, and subside. That process would tend to speed up the formation of dead pannes. Or the ditch margins, like dikes, may have simply held the tidal water in the salt hay areas longer than the plants could handle, and the stress eventually caused the death and decay of the typical high marsh meadow vegetation. Salt marsh plants can tolerate a twice daily saltwater bath, but not a continual soaking in salt water. Purple loosestrife has not invaded the Bass Beach Marsh because the soil there is too salty and too constantly submerged. It exists only along some of the upper margins of the marsh and is not abundant.

Bass Beach Marsh showing extensive nonproductive dead panne areas.

Additionally, ditching should be done to drain some of the dead panne areas of standing water. Although the ditches are the probable cause of the dead pannes, only breaking through their higher rims with drainage ditches will alleviate the conditions that have produced these dead panne areas. Such ditching, when combined with the creation of an open channel, except under Route 1A, should provide enough flooding and drainage of the Bass Beach Marsh to restore it to high marsh over a period of time.

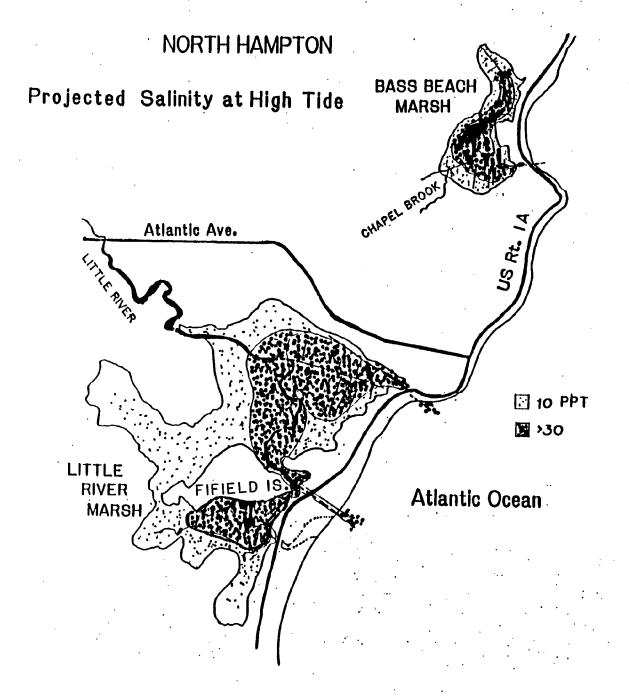
Salt Water Intrusion After Recommended Changes

Projected salinity distributions at the Little River Marsh and Bass Beach Marsh after recommended changes in hydrology are instituted. Note the extension of high salinity water into the southern and northern ends of Little River Marsh, the projected result of a second culvert installed near Fifield Island. At Bass Beach Marsh the extent and level of salinity is projected to increase throughout the marsh.
